**DEPARTMENT OF TRANSPORTATION**

Contract #: 04-0120F4Cty: SF/ALA Rte: 80 PM: 13.2/13.9File #: 69.28**WELDING INSPECTION REPORT****Resident Engineer:**Siegenthaler, Peter**Address:** 333 Burma Road**City:** Oakland, CA 94607**Report No:** WIR-017768**Date Inspected:** 04-Nov-2010**Project Name:** SAS Superstructure**OSM Arrival Time:** 700**Prime Contractor:** American Bridge/Fluor Enterprises, a JV**OSM Departure Time:** 1900**Contractor:** Zhenhua Port Machinery Company, Ltd (ZPMC), Changxing Island **Location:** Shanghai, China**CWI Name:** Li Yang**CWI Present:** Yes No**Inspected CWI report:** Yes No N/A**Rod Oven in Use:** Yes No N/A**Electrode to specification:** Yes No N/A**Weld Procedures Followed:** Yes No N/A**Qualified Welders:** Yes No N/A**Verified Joint Fit-up:** Yes No N/A**Approved Drawings:** Yes No N/A**Approved WPS:** Yes No N/A**Delayed / Cancelled:** Yes No N/A**Bridge No:** 34-0006**Component:** OBG Segment**Summary of Items Observed:**

**OBG # TRIAL ASSEMBLY YARD (TOWER LIFT 3 SOUTH)**

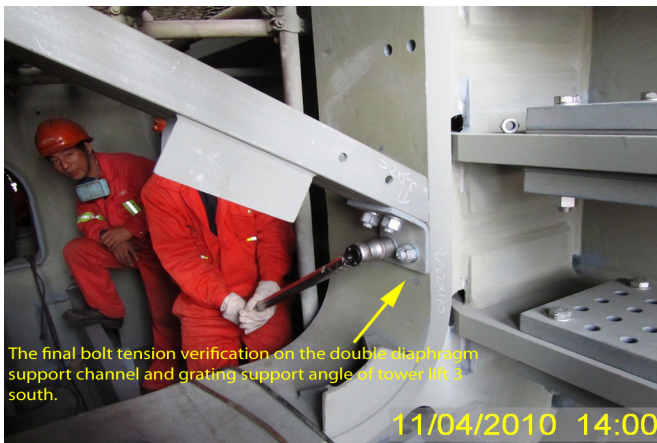
This QA inspector witnessed the final bolt tension verification on the double diaphragm support channel and grating support angle of tower lift 3 south. The torque wrench S/N was X02-74. The QA inspector witnessed 10% of the bolts on a random basis and found the tensioning of the bolts appeared to be in general compliance with the contract specifications. The bolt size designations were as follows:
